Scaffolding and Impact Hazards

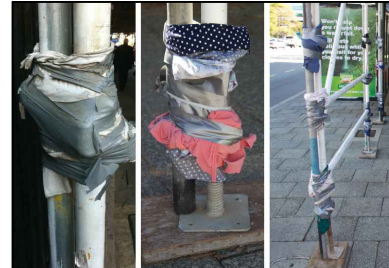
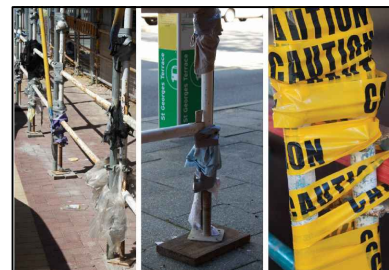
OLD (INADEQUATE) METHOD:

In the past, impact hazards were either painted or covered with old rags and duct tape. These methods were time consuming, costly, didn't completely mitigate the hazard, and contributed to waste issues. The City of Perth has agreed that using rags and duct tape is unsightly and unprofessional and no longer adequate for the streets of Perth.

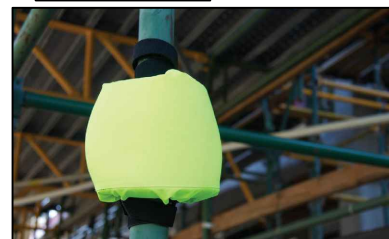
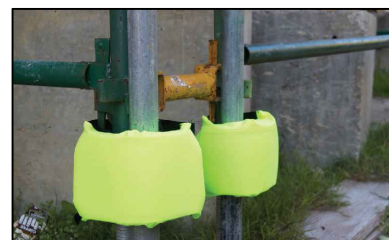
NEW METHOD:

- The method uses a high quality foam safety pad attached with Velcro straps and features reinforced steel eyelets for securing with cable tie to deter theft.
- These items are adaptable, reusable and effective in the public arena.
- They are readily available in Perth.

- Reduces the likelihood of impact by highlighting the hazard using high-vis material
- Reduces the consequences by covering the hazard with protective padding

Please see the photographs which demonstrate how the new method is being employed.
